TECHNICAL REPORT 4321

IN - BORE PREMATURE
MALFUNCTION INVESTIGATIONS
OF THE
81 MM HIGH EXPLOSIVE MORTAR CARTRIDGES
WITH THE
M526, M524A5 AND XM176
POINT DETONATING FUZES

JOHN MCPARTLAND
WILLIAM PICK

FEBRUARY 1972

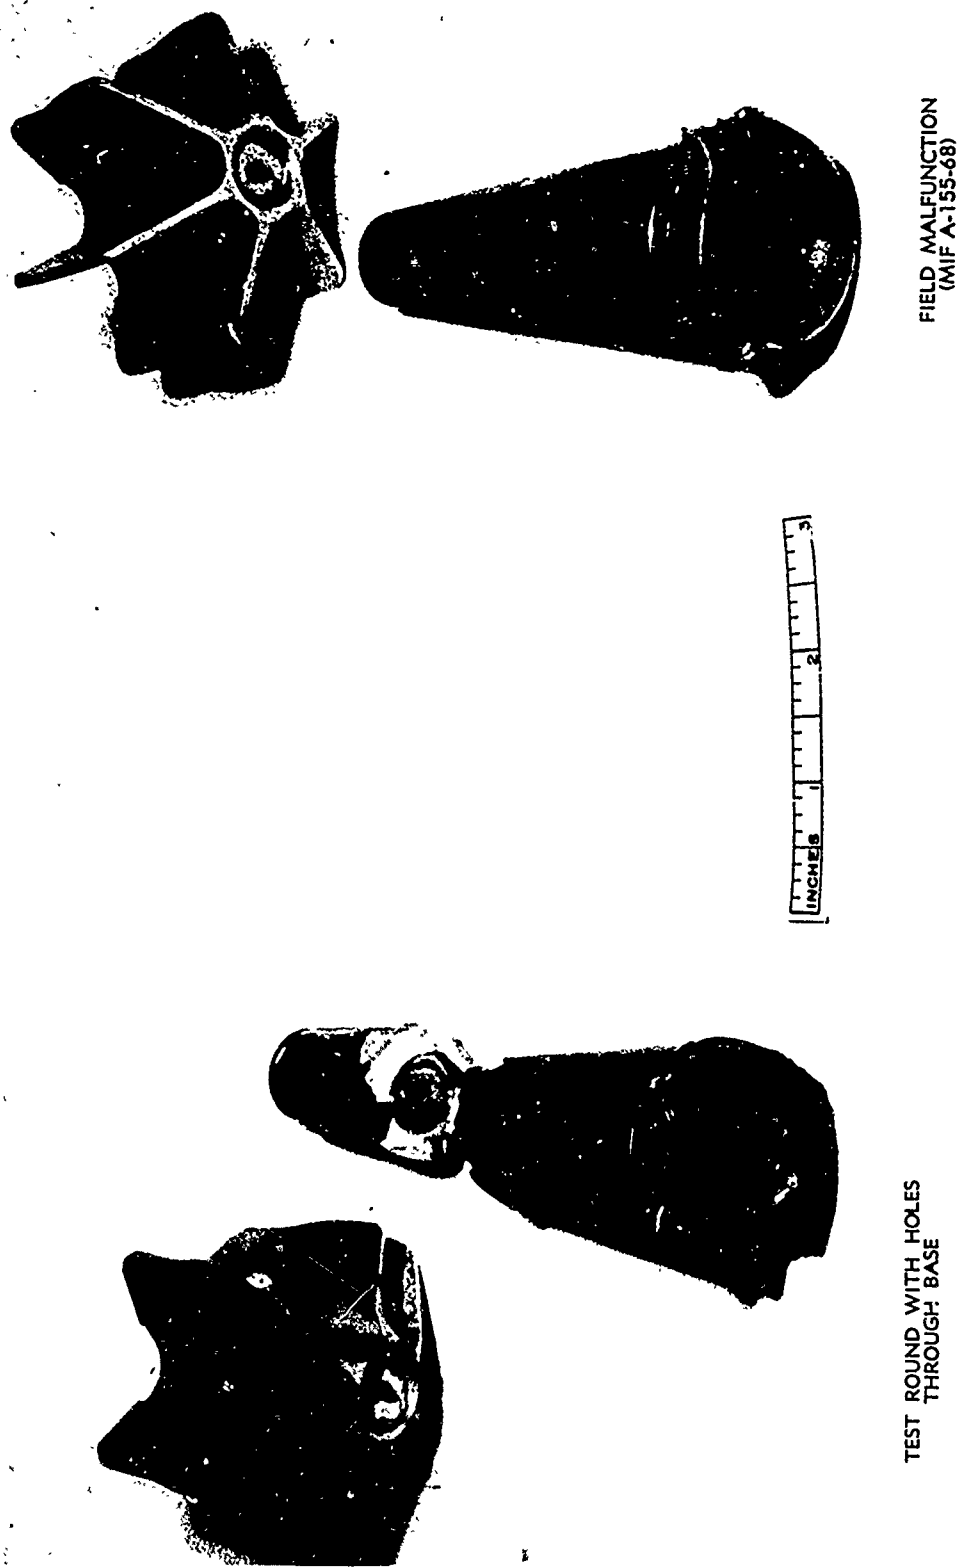
Figure 14. Large fragments from base of shell and fin assemblies

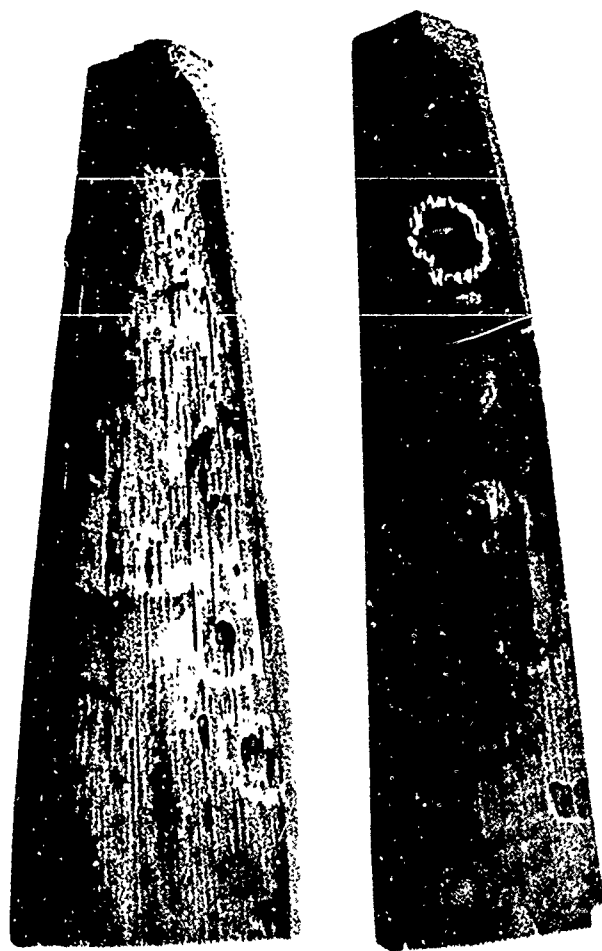
All projectile samples, including factory rejects, were tested for Rockwell hardness (Table 10) and x-rayed along the longitudinal axis. A minimum of 40 samples from each lot were x-rayed twice, 90° apart. There were no cracks in the shell or voids in the HE filler. Some x-rays showed dark spots which indicated thin material in the wall of some shells. The thin material (pits) also were detected in the ultrasonic test. A cutaway section of a shell showing pit marks is in Figure 20.

Each shell was subjected to an ultrasonic test. The pits observed in x-rays were recorded in these tests. The pits measured from 0.021-0.032 inch deep. The wall thickness adjacent to the pits measured 0.208-0.212 inch thick.

Figure 20. Sections of shell bodies with pits on inside surface

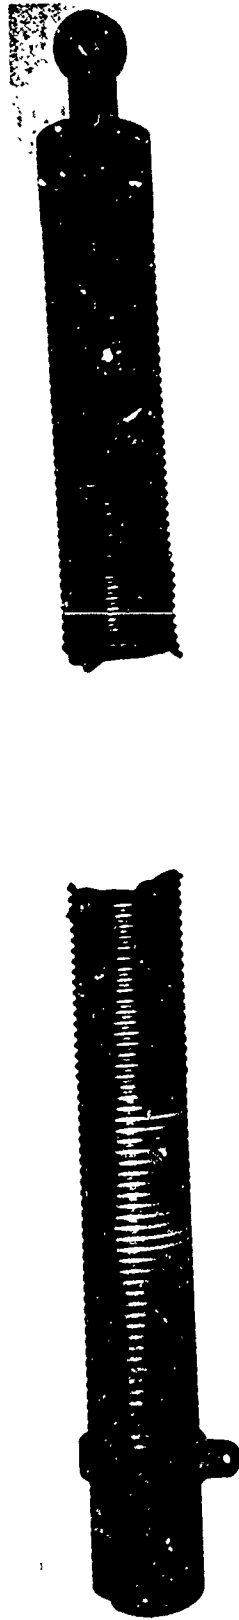
Figure 22. Fragments of tube involved in in-bore
premature malfunction (MIF A-155-68)

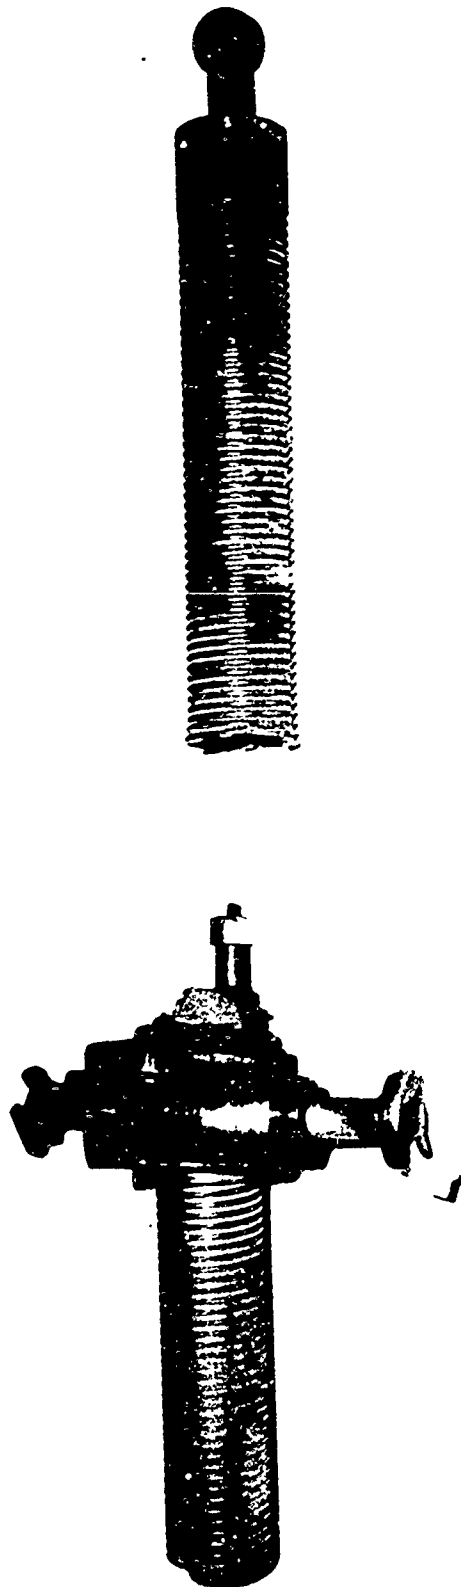
Figure 26. Fragments from tube involved in in-bore premature malfunction (MIF A-41-69)
